# THE COUPLING EFFECT FROM THE ACTION OF MULTIPLE FACTORS ON THE COMPOSITE WALL WITH OUTER LIGHTWEIGHT INSULATING LAYER

## ABSTRACT

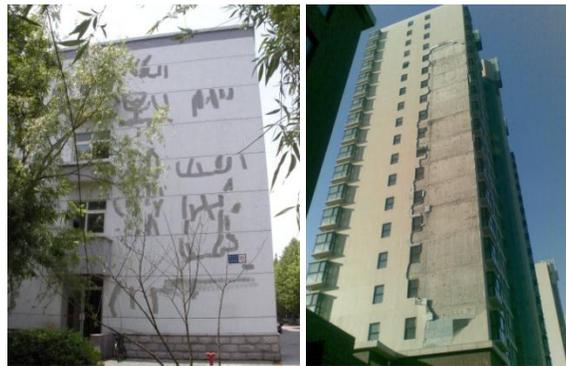
Fig.1 Damage of the covering plaster layer

Since the 1980s, dozens of outer lightweight insulating systems have been developed in China. And some insulating systems have been used in buildings to meet the demand of energy conservation. However, the plaster covering layers were damaged in many external walls with outer lightweight insulating system (as shown in Fig.1). This kind of damage brings many problems such as reducing the energy-saving efficiency, increasing the risk of causing personal injury or property loss and defacing the building [1].

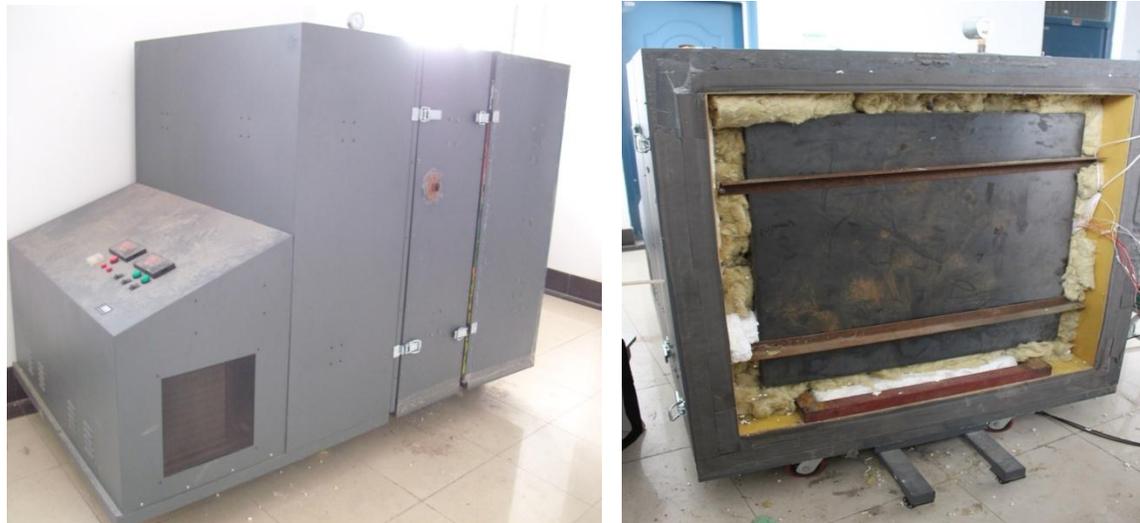
(a) (b)  
 Fig. 4. Device and installation of the specimen  
 (a) Test device; (b) Internal view of the completed specimen

In order to test the coupling effect, a special device is designed to simulate the joint action of temperature difference, gravity and wind. As Fig. 4 shows, the device is consisted of two hot boxes and one specimen rack, which lies between the two hot boxes. The temperature difference will be simulated by the two boxes with different temperatures. The surface of a specimen could be covered with a sealing steel cap so that a cavity will be formed and the wind impact could be simulated by evacuating or pumping the cavity. The schematic diagram of the specimen installation is shown as Fig. 5
